Karara Mining Limited Chute39+99 modification background

CH039 Chute Modification Background

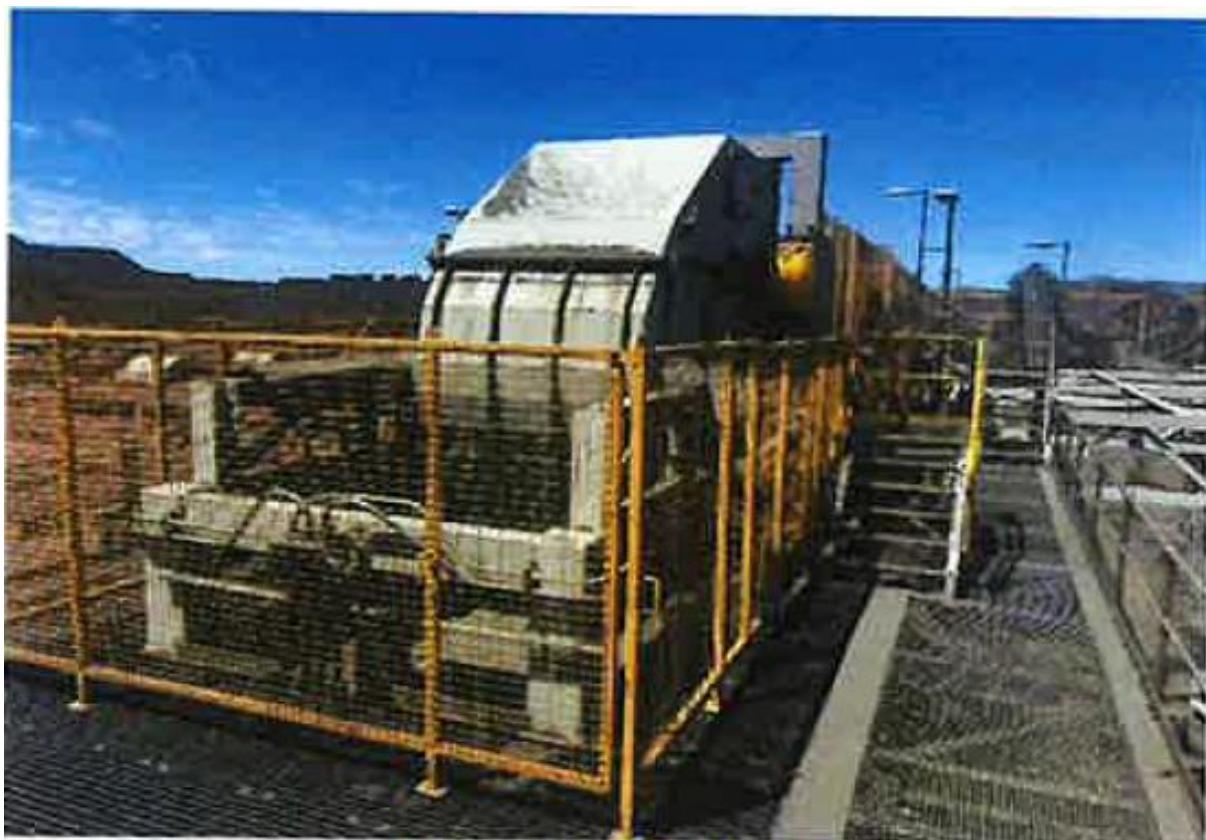
Figure 1 Site photo

The CH039 moving head chute has experienced numerous downtime events due to repeated issues with the wheel assemblies and rail weld cracking. The wheels have shown a short lifespan, primarily caused by uneven forces by the two hydraulic cylinders during operation. This uneven loading results in misalignment and excessive stress on the wheel assemblies and rail welds, eventually leading to premature failures and unplanned maintenance.

To address these ongoing issues and improve overall system reliability, it is proposed to modify the CH039 moving head chute into a fixed central chute. Converting the chute to a fixed configuration will eliminate the uneven loading from the hydraulic system, reduce maintenance frequency, and provide a long-term, stable solution for the current reliability problems.

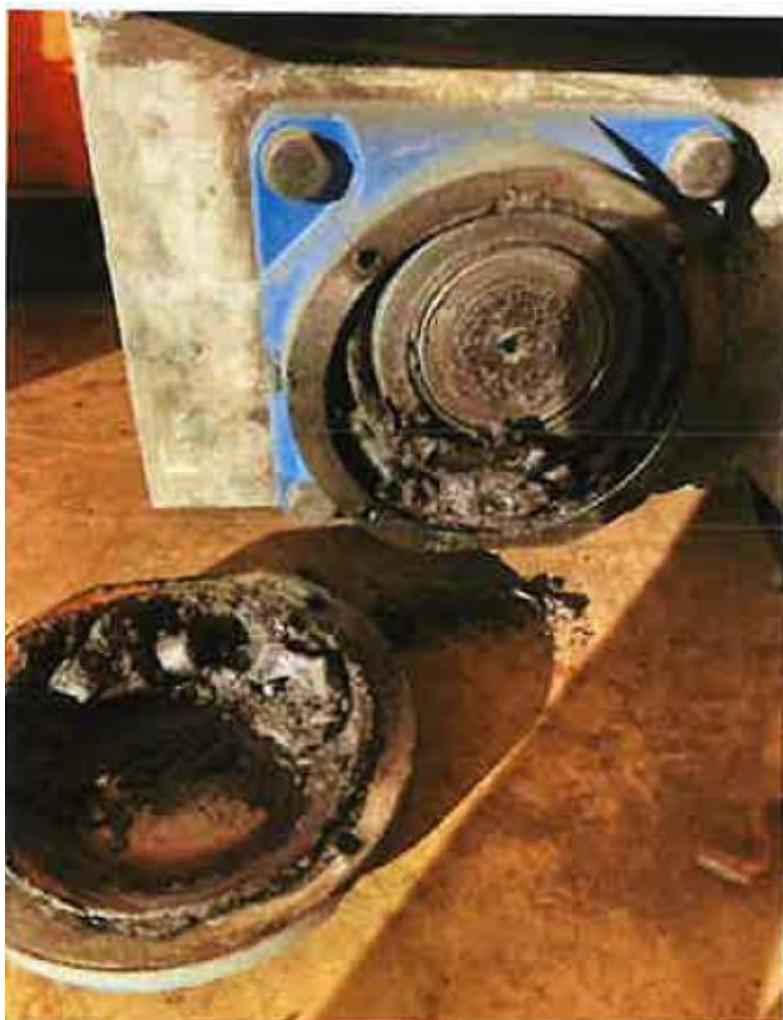
Figure 2 Site photo

Wheels are damaged with bearing cracks.

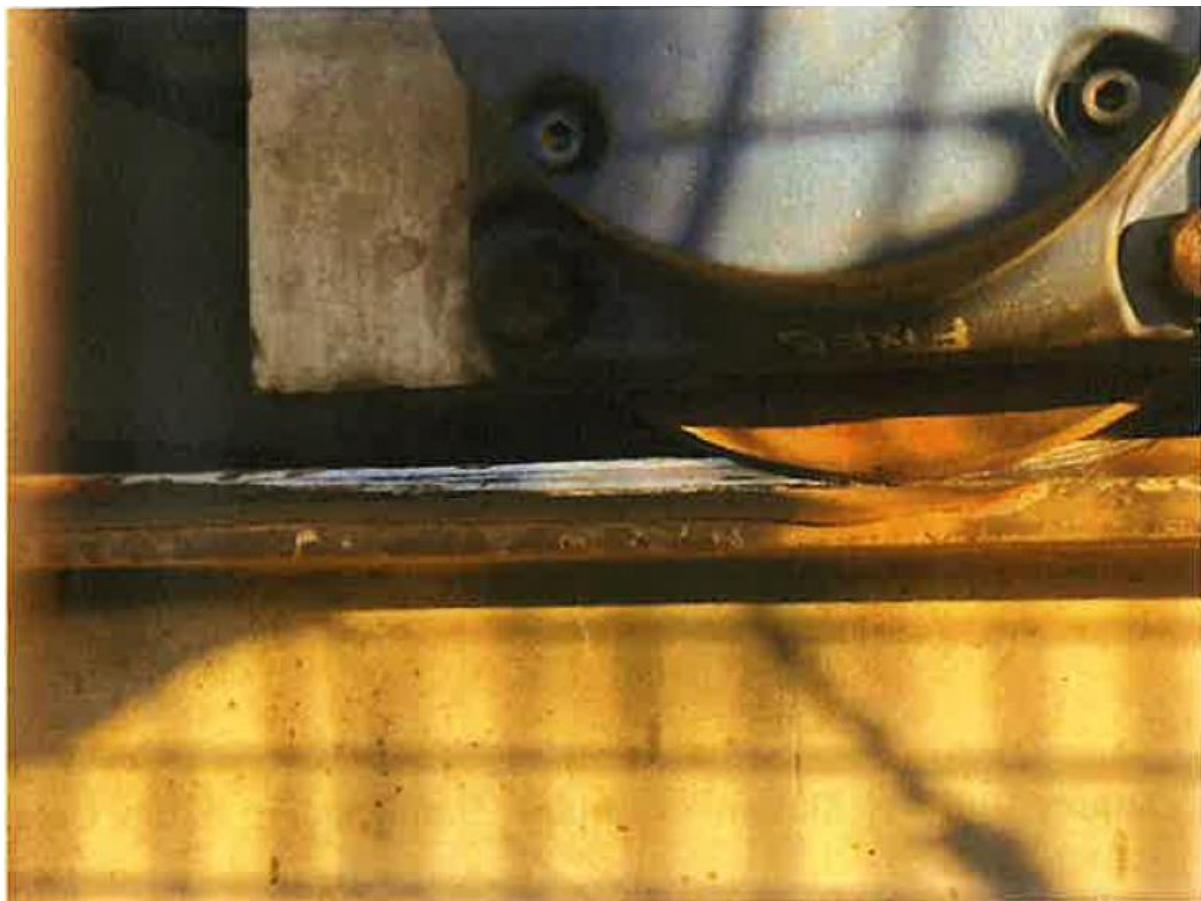
Figure 3 Site photo

Damage on the CH39 north side rail

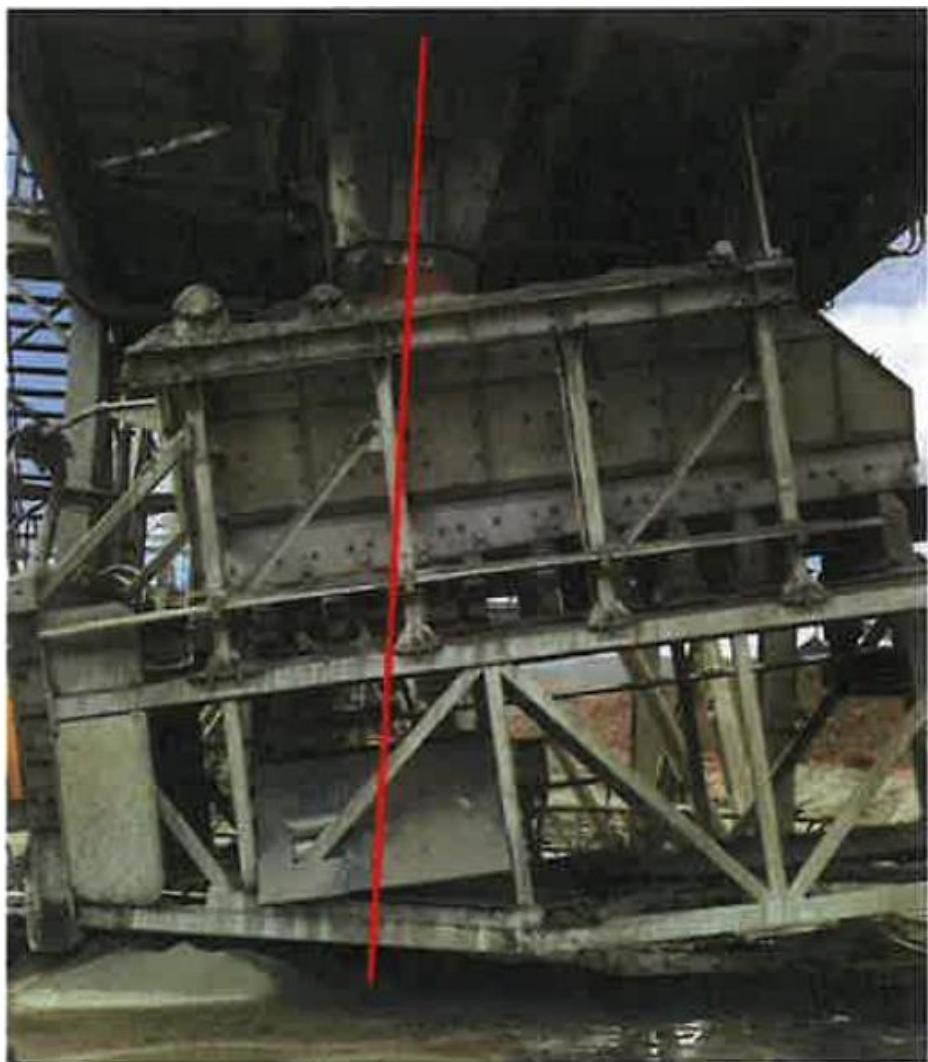
Figure 1 Site photo

ST009 has a drafting and spillage issue. The reasons are as follows:

- 1) ST009 pivot pin and CH099 loading point are offset, which affects belt loading depending on the angle of slew.

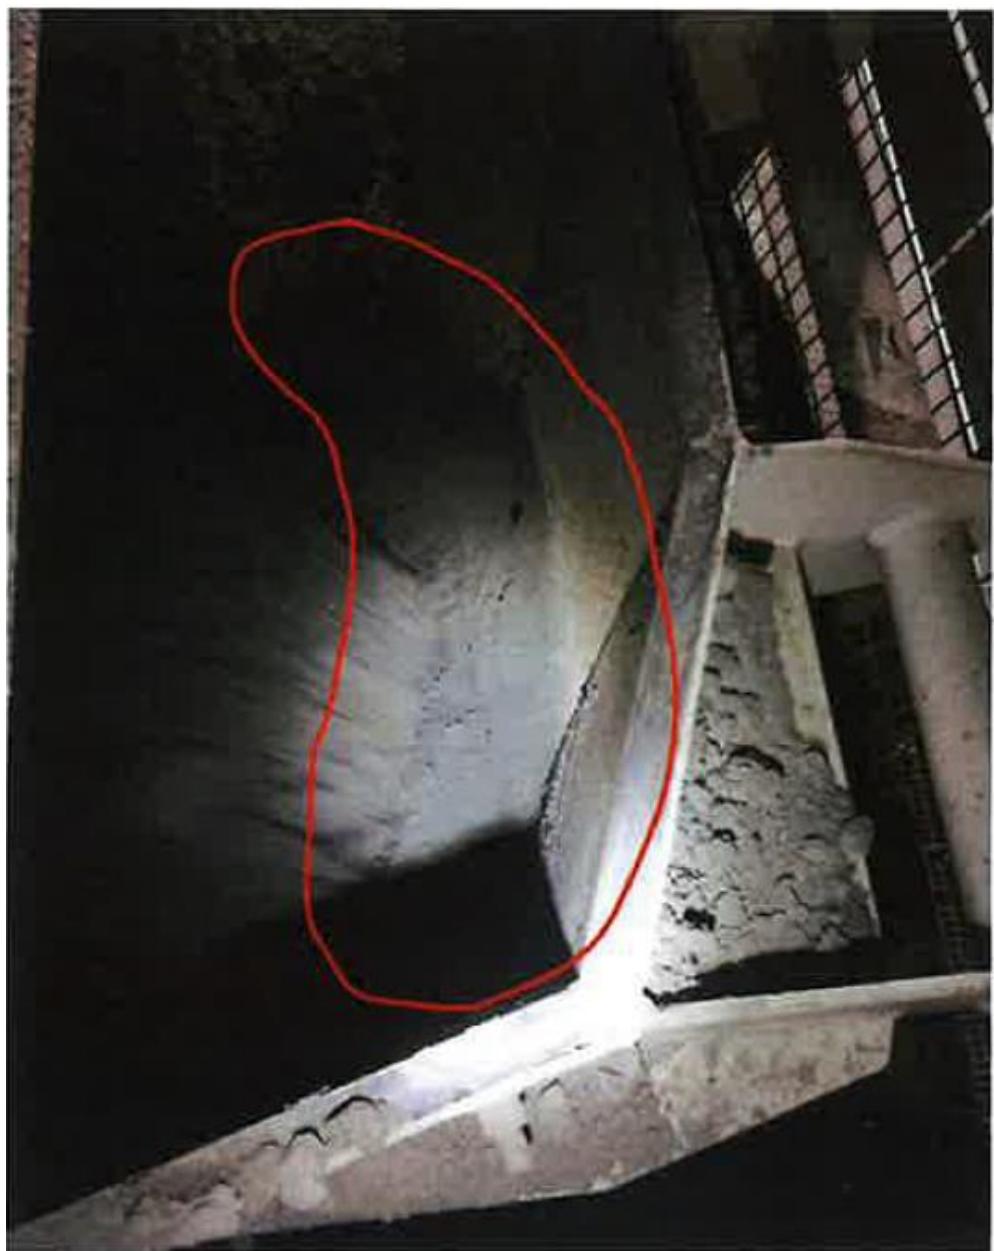
Figure 2 Site photo

2. Intermittent material build-up (rhino-horn) on the impact plate causes variances in the material flow path.

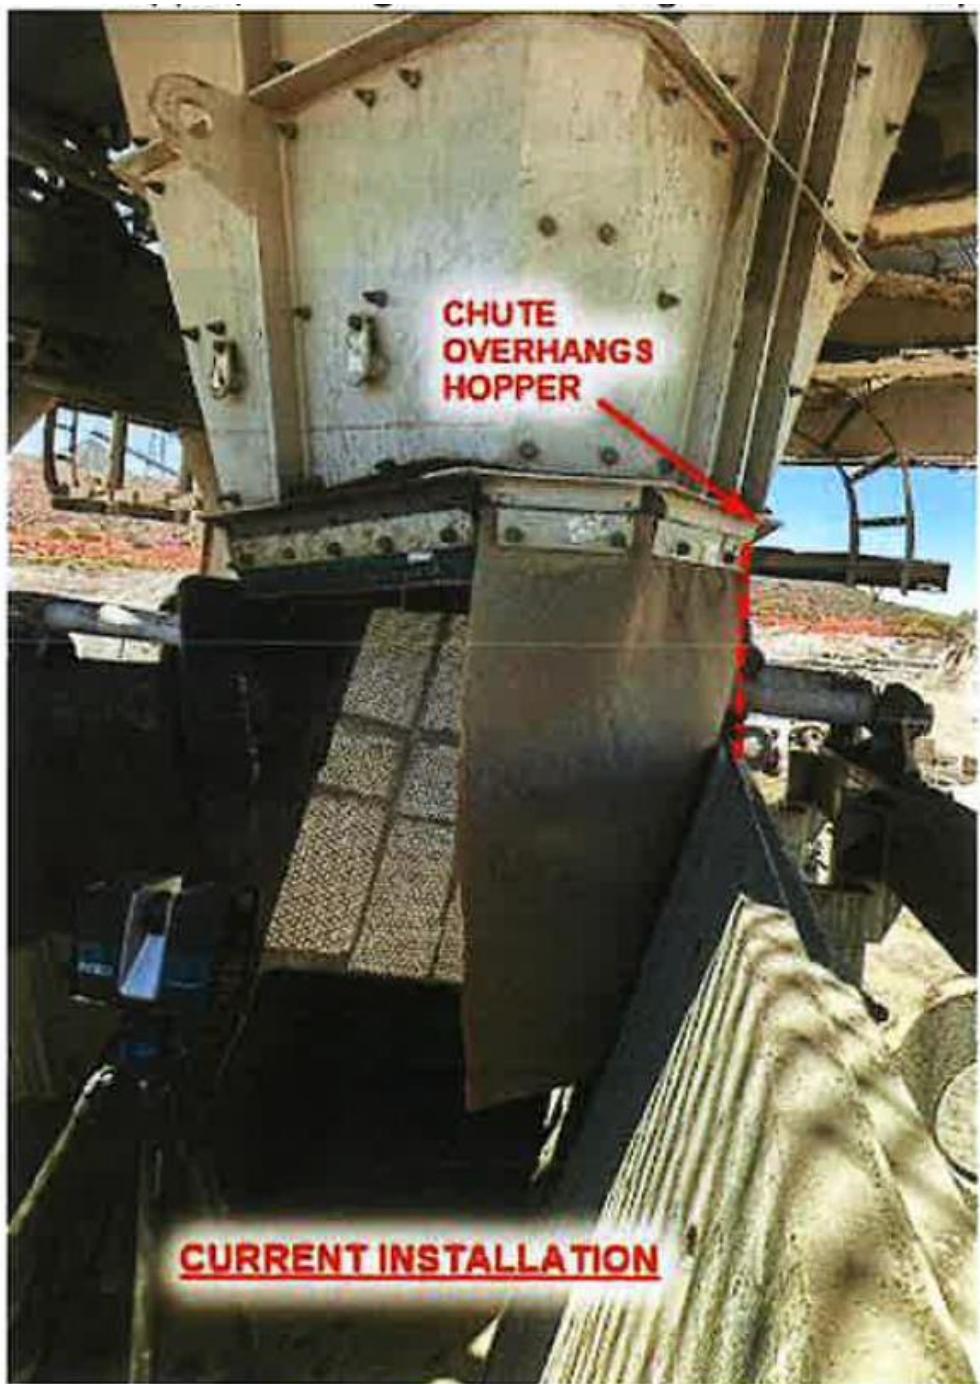
Figure 3 Site photo

3. Chute overhangs ST009 Hopper, leading to side loading and material spilling.
